Micromechanical Investigation of Fatigue Damage in Uni-Directional Fibre Composites

Proceedings of 6th International Conference on Fatigue of Composite

2015

MICROMECHANICAL INVESTIGATION OF FATIGUE DAMAGE IN UNI-DIRECTIONAL FIBRE COMPOSITES

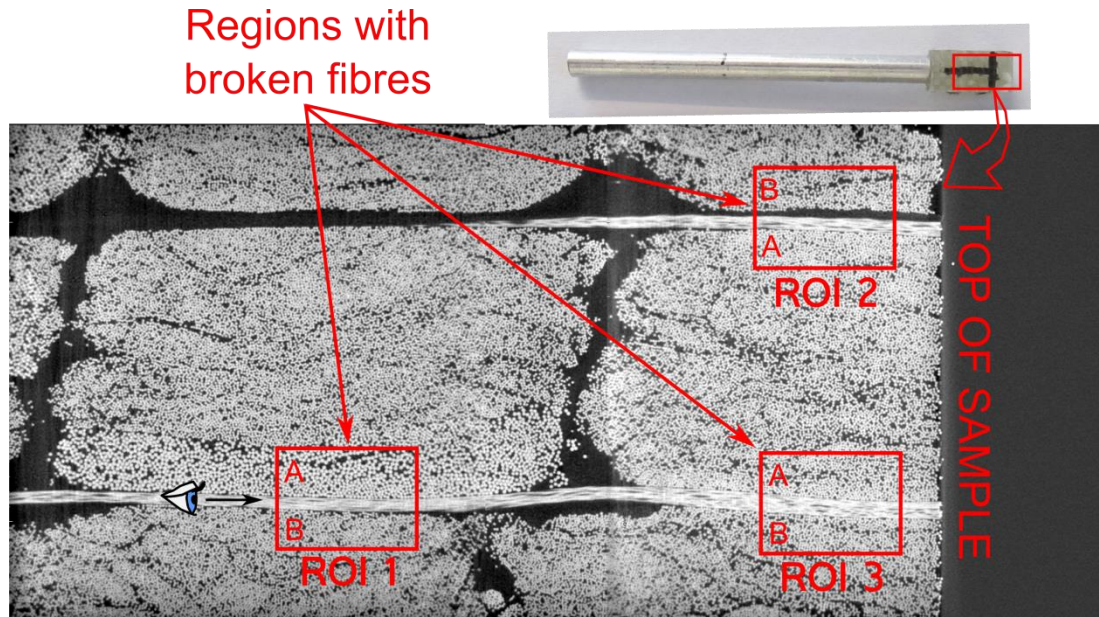
Figure 5 shows a 2D view in the centre of the sample obtained by combining scan 2-4. The whole volume, including all three scans, was carefully examined visually. The only locations where broken fibres could be seen are in the three regions of interest (ROI 1-3) indicated in Figure 5. The indicated regions are volumes which continue out of plane in the direction of the UD bundles. Broken fibres were only observed locally close to the backing layers, hence no broken fibres were observed further within the UD bundles or close to the cut surface at the top of the sample. Since no damage was observed at any other positions than locally at the backing, it is not believed that the cutting of the sample has an effect on the marked regions of interests. It should be noted that the observed broken fibres are based on subjective visual inspection.

Figure 5: A 2D slice in the centre of the data set showing regions of interest in relation to broken fibres. Location A marks the side to which the UD bundles are stitched to the backing layer, and B marks the side which is not stitched to the nearby backing layer.

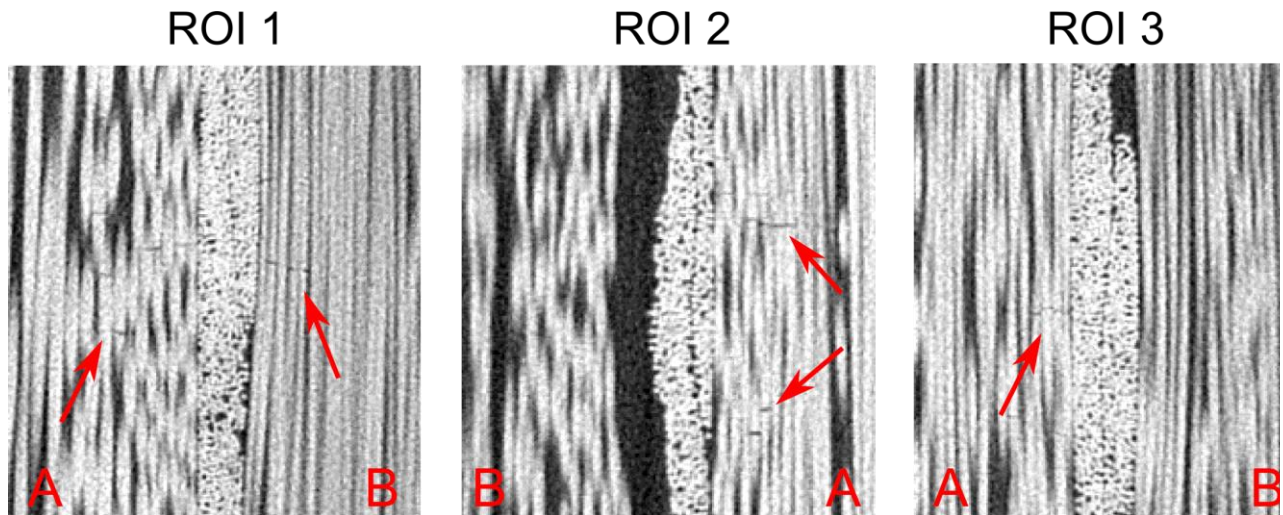
Figure 6 shows examples of broken fibres at the three ROIs using the viewing direction indicated in Figure 5.

Figure 6: Regions with observed broken axial fibres all include intertwining backing bundles in direct contact with a UD bundle.

A common observation for the three locations where broken fibres were observed is the presence of a double backing bundle, which also can be seen in Figure 6. However, broken fibres are not observed at all positions with intertwining bundles in contact with a UD bundle. For this reason it seems that additional factors have an effect on where the fibre fractures occur. It is interesting to note that the axial fibres in side B of ROI 2, Figure

6, are not damaged at all – perhaps due to the resin interlayer. The local fibre misalignment in a plane parallel to the backing layer in the UD bundles in ROI1A is between 5-10 degrees, whereas almost no misalignment is observed in the other regions with observed broken fibres. Additionally the local fibre volume fraction close to the backing in the ROIs is high, and the fibre diameter is varying. Since there are many factors which can influence the damage progression, further studies on a larger volume should be performed to study the effect in more detail. Performing a quantitative study on a larger volume based on an automated procedure is currently work in progress.

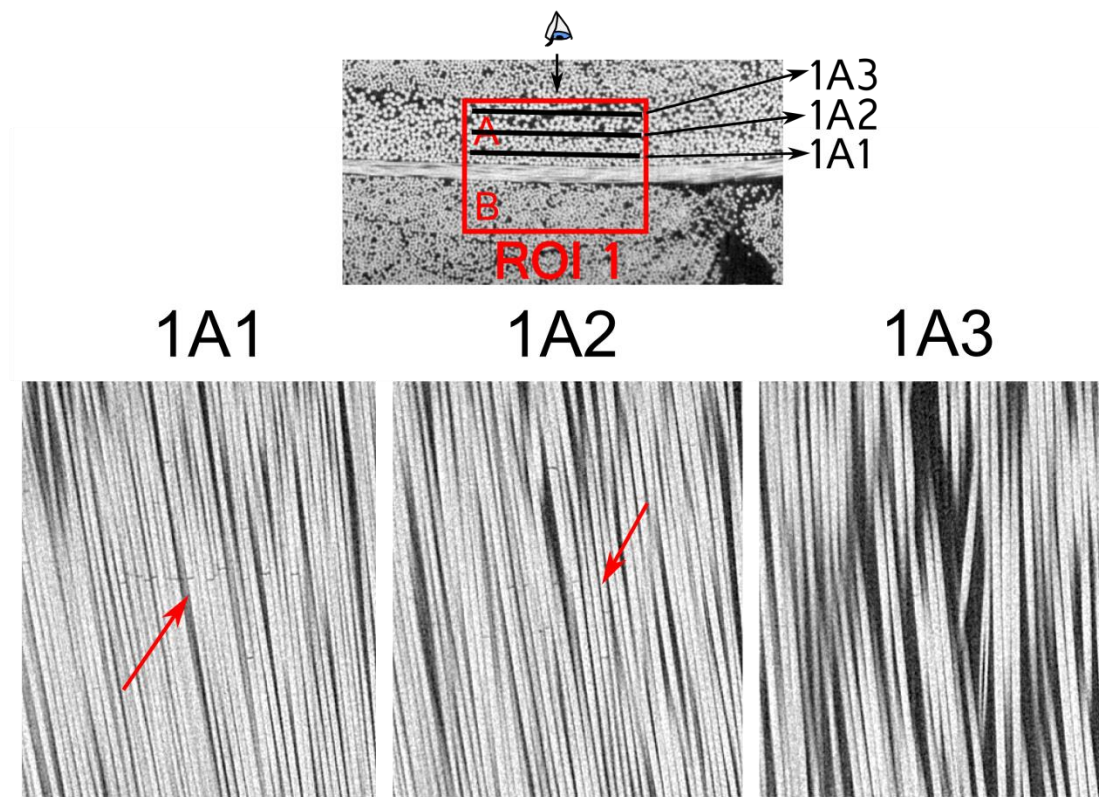
Figure 7 shows the broken fibre distribution in ROI 1 when looking towards the backing layer at a plane and moving further away from the backing.

Figure 7: The distribution of broken fibres in region of interest 1 at three locations.

Figure 7 the broken fibres are seen to initially be lined up (1A1) in the vicinity of the backing, and spread out in a larger area when moving further into the UD fibre bundle (1A2). It could be that a matrix crack in the backing has propagated into the bundle, causing the almost straight line of breakage, and that these cracks then propagate along the fibre interfaces and penetrate the fibres at weak locations, causing the fibre breaks to spread out. However, it was not possible to see interface or matrix cracks in the performed scans (larger resolution needed), so it cannot be confirmed at this time. The broken axial fibres are only observed locally close to the backing, and it is seen that in ROI1 there are already no observed broken fibres in 1A3, Figure 7. It is likely that this damaged area would keep increasing in size if the fatigue test was continued, as postulated by Zangenberg et al. [4].
